**PROGRAM FOR EXPERIMENTAL INVESTIGATION OF FAILURE
PROGNOSIS OF HELICOPTER GEARBOXES**

**Northrop Research and Technology Center
3401 West Broadway
Hawthorne, Calif. 90250**

August 1976

Final Report

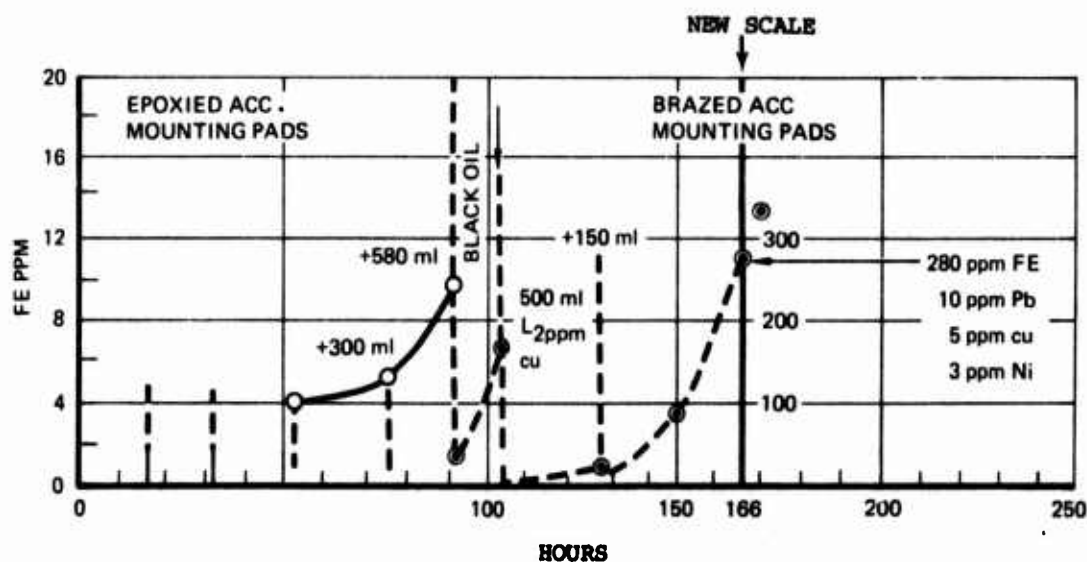
Oil data was collected at regular intervals during the testing of the BB gearbox. Duplicate samples were taken and supplied to the Eustis Directorate for future in-house testing of other types of oil debris sensors. Figure 49 summarizes the results of the SOA on the BB gearbox.

Figure 49. Summary of BB Gearbox SOA.

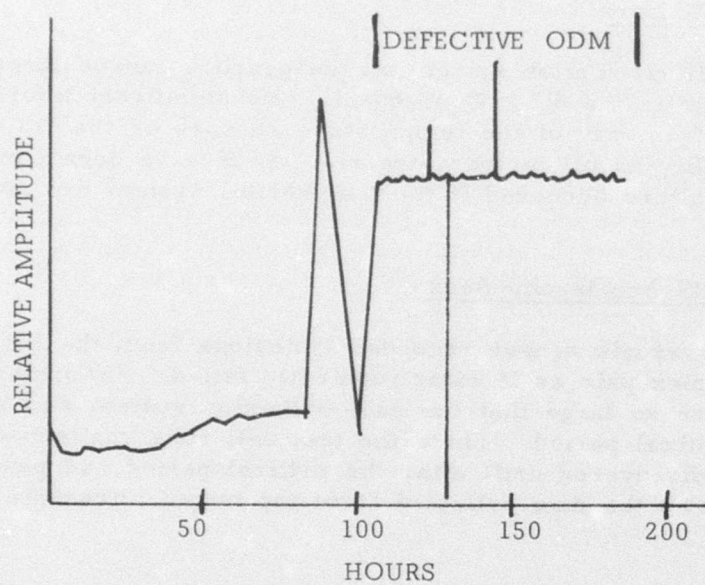
This abrupt change in sensor level occurred within a 4-minute sampling interval and correlates with a corresponding step-like change in signal from the output ultrasonic accelerometer. We now know that the X-ray fluorescence ODM was probably not functioning properly during the testing of gearbox BB, but it appears that it did detect the sudden increase in iron concentration which occurred at test hour 75. The ODM failure occurred when the molybdenum window fractured. The exact time of failure is not known, but we suspect that it occurred when the step-like increase in its output occurred at test hour 75 or shortly after. After the oil was changed at 100 hours, this ODM still registered full scale, which indicated that the sensor had failed. When the capacitance ODM did not detect the high concentration of metals observed in the SOA, we assumed that it was either defective or had a sensitivity far below the manufacturer's specifications. Figure 51 shows an SEM picture of some of the metallic debris removed from the measurement capacitor in the capacitance type ODM.

Figure 50. Output of X-ray Fluorescence ODM.

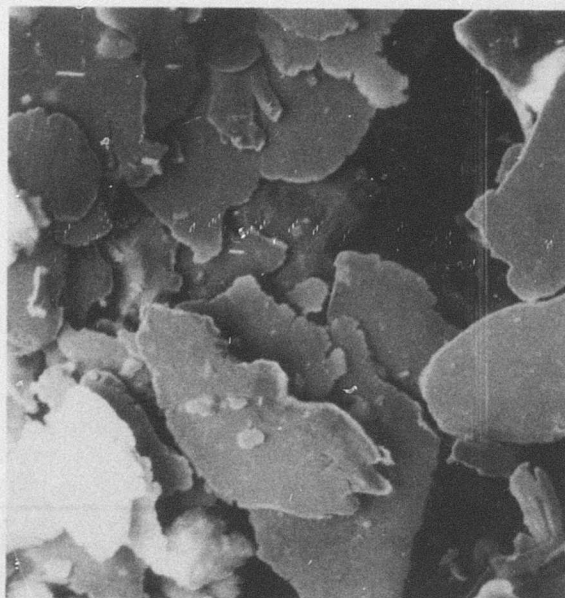
Figure 51. Oil Debris Found in Measurement Capacitor of Capacitance Type ODM.

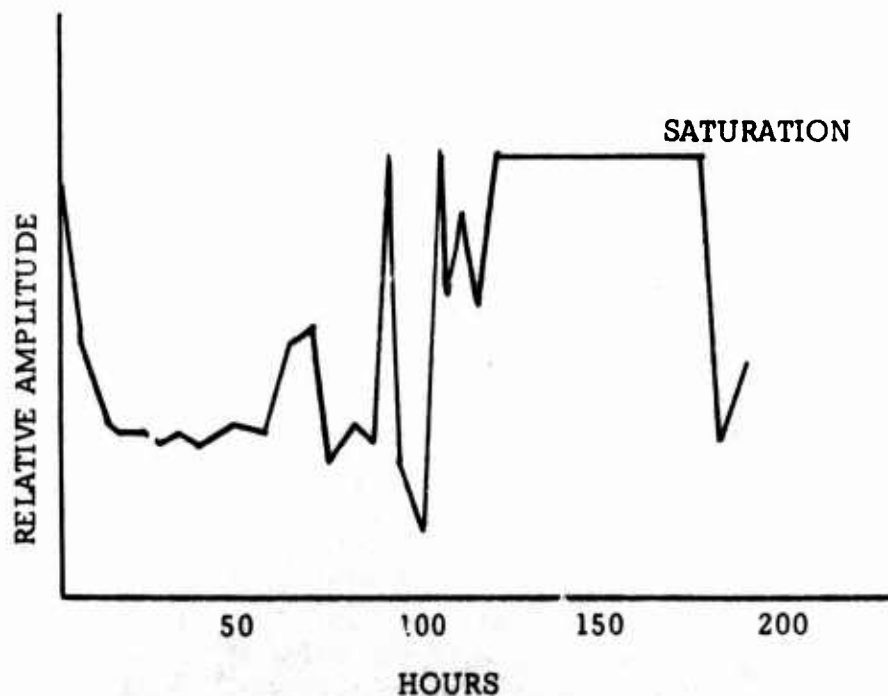
The output ultrasonic sensor recorded emissions from the BB gearbox output duplex pair as it catastrophically failed. Unfortunately, the emissions were so large that the data collection system was saturated during the critical period. Since the test cell runs unattended, this fact was not discovered until after the critical period had passed. Figure 52 shows the data collected from the output ultrasonic sensor.

Figure 52. Ultrasonic Data From Output Ultrasonic Accelerometer.

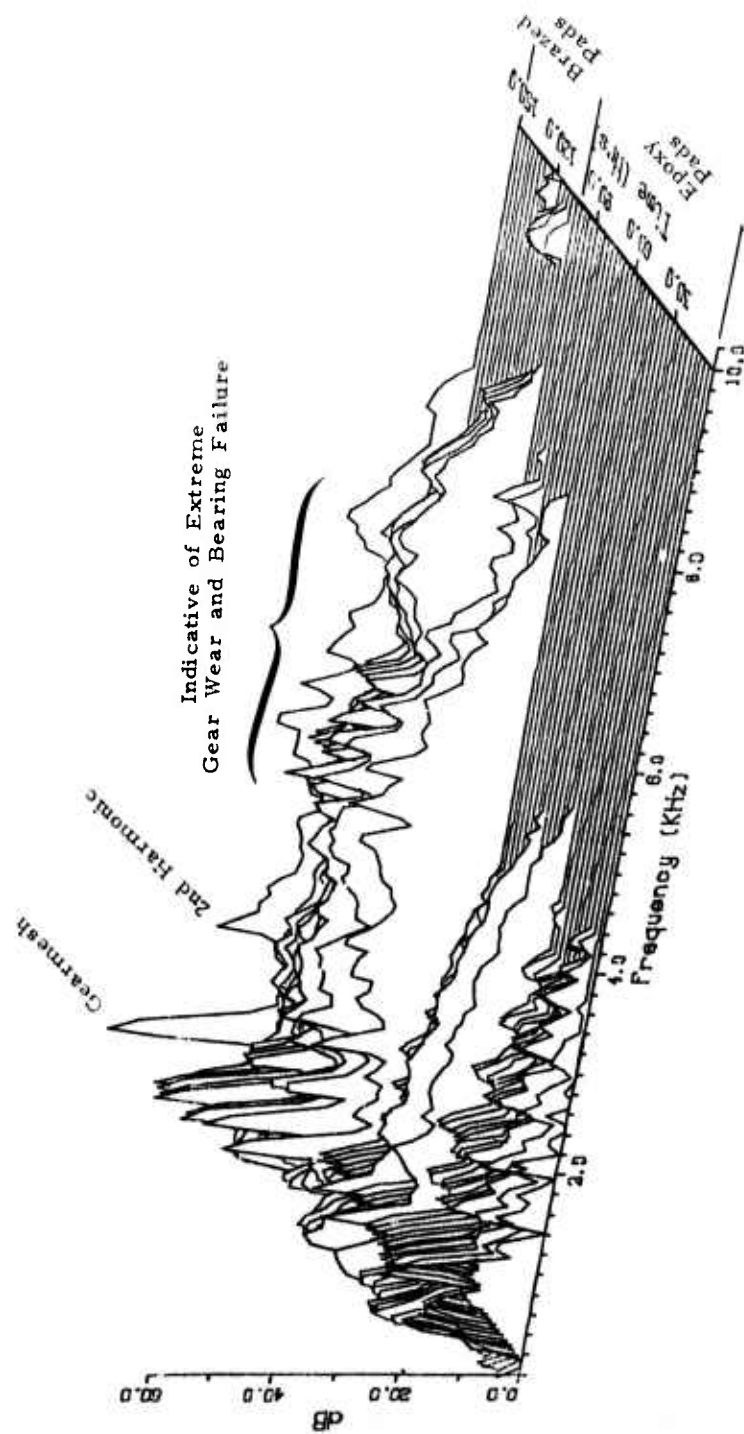
Figures 53, 54, and 55 show an overall view of the vibration data collected from the three low-frequency accelerometers on the BB gearbox. Note the significant increase in energy in the high-frequency components and the total absence of a recognizable gearmesh harmonic structure (see HT data base for comparison, Figures 44,

Figure 53. Overall View of BB Vibration Data Base, Input Lateral Accelerometer.

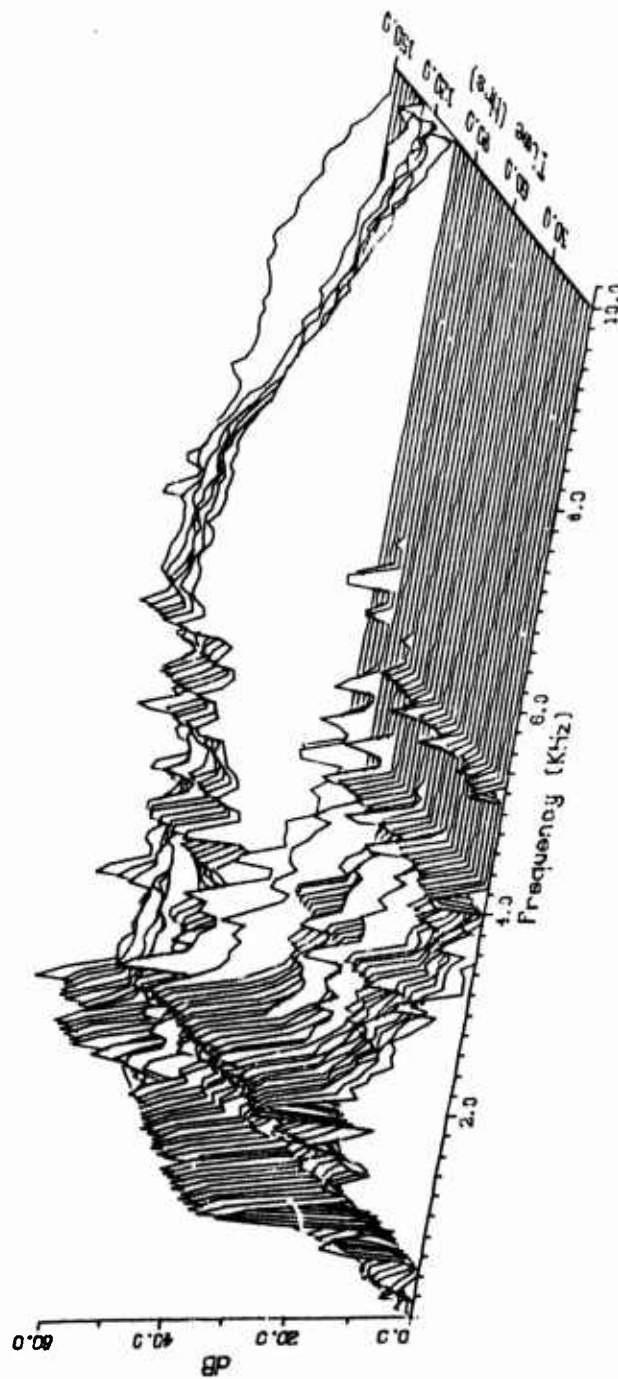
Figure 55. Overall View of BB Vibration Data Base, Output Lateral Accelerometer.

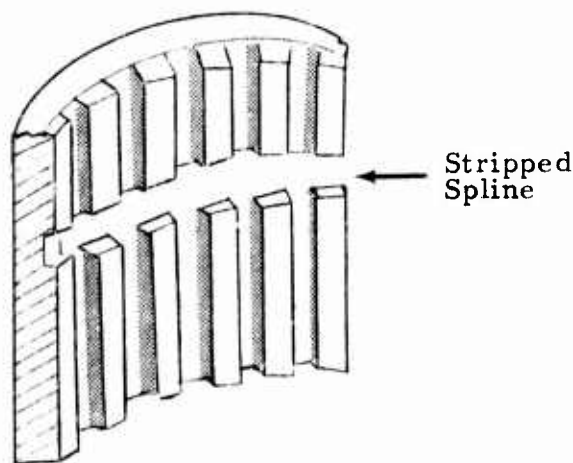
At test hour 246 of the second test period, the input coupling of the gearbox failed. This is a gear-type coupling designed to accommodate shaft expansion and misalignment. The splines in the outer portion of the input coupling (the portion supplying power to the gearbox) fractured, allowing the high-speed test cell jack shaft to spin freely. Figure 62 illustrates a cutaway section of the outer part of the coupling, detailing the nature of the failure. This coupling is part of the gearbox and not a part of the test cell.

Figure 62. Cutaway Sectional Illustration of Failed Input Coupling.

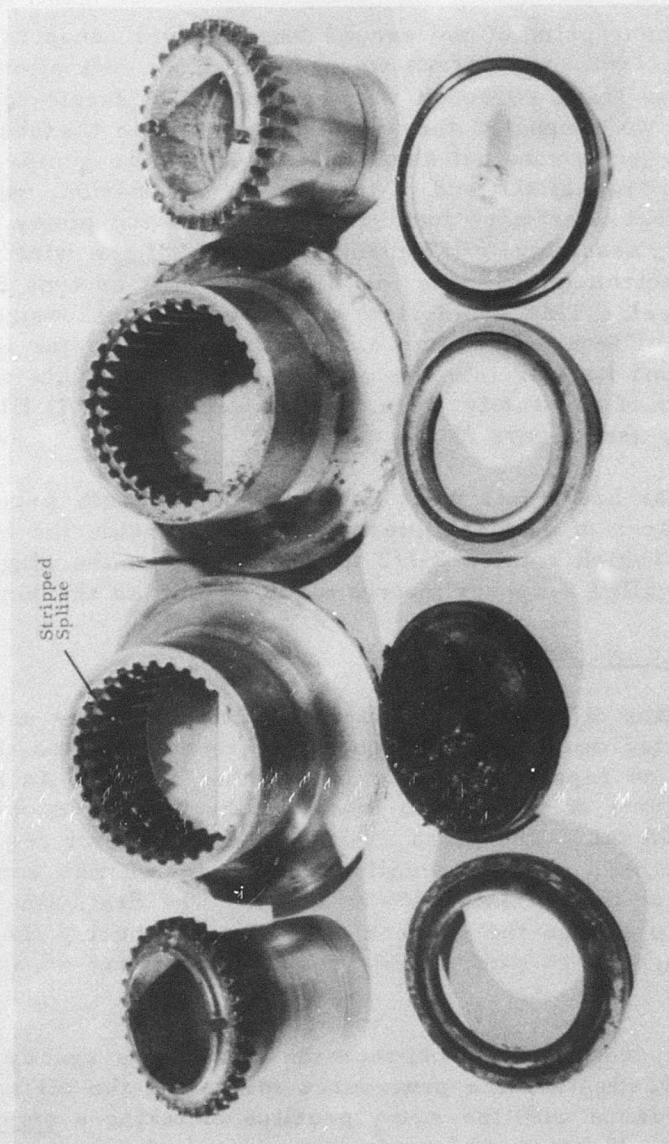
Figure 63. Comparison of Failed Input Coupling With Good Coupling.

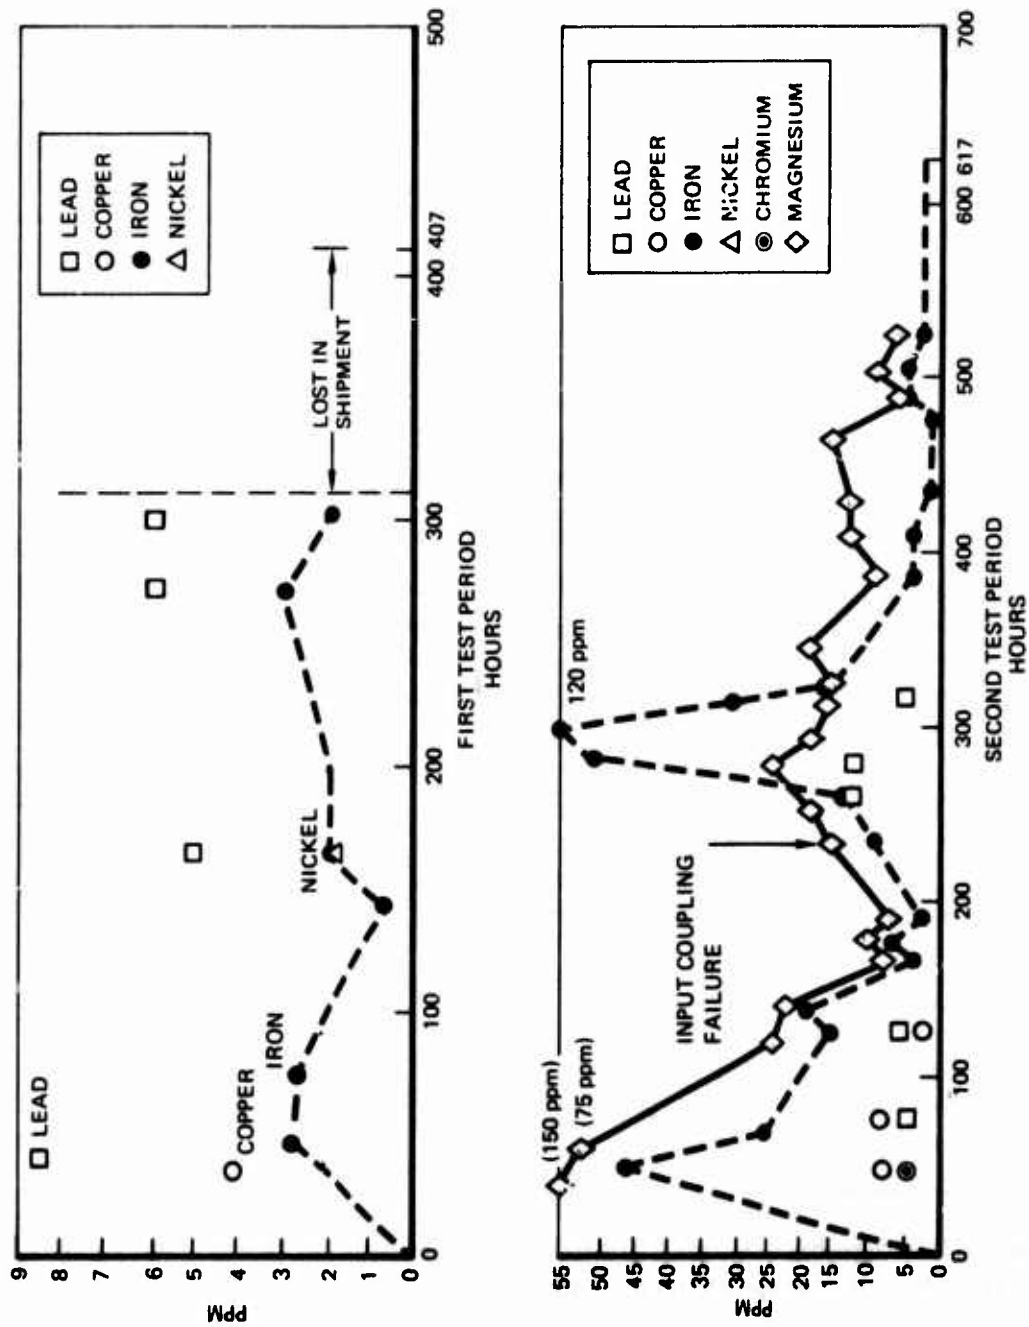
Due to a misunderstanding between the contracting agency and the principal investigator, the procedures for taking the oil samples were not in accordance with the Army practice of taking a small oil sample every 25 hours and performing an oil change every 100 hours. The oil analysis data gathered during the testing of the BBT gearbox is shown in Figure 64. The oil samples were not taken at regular intervals, but the oil was changed at the time corresponding to each

Figure 64. Summary of BBT Gearbox SOA.

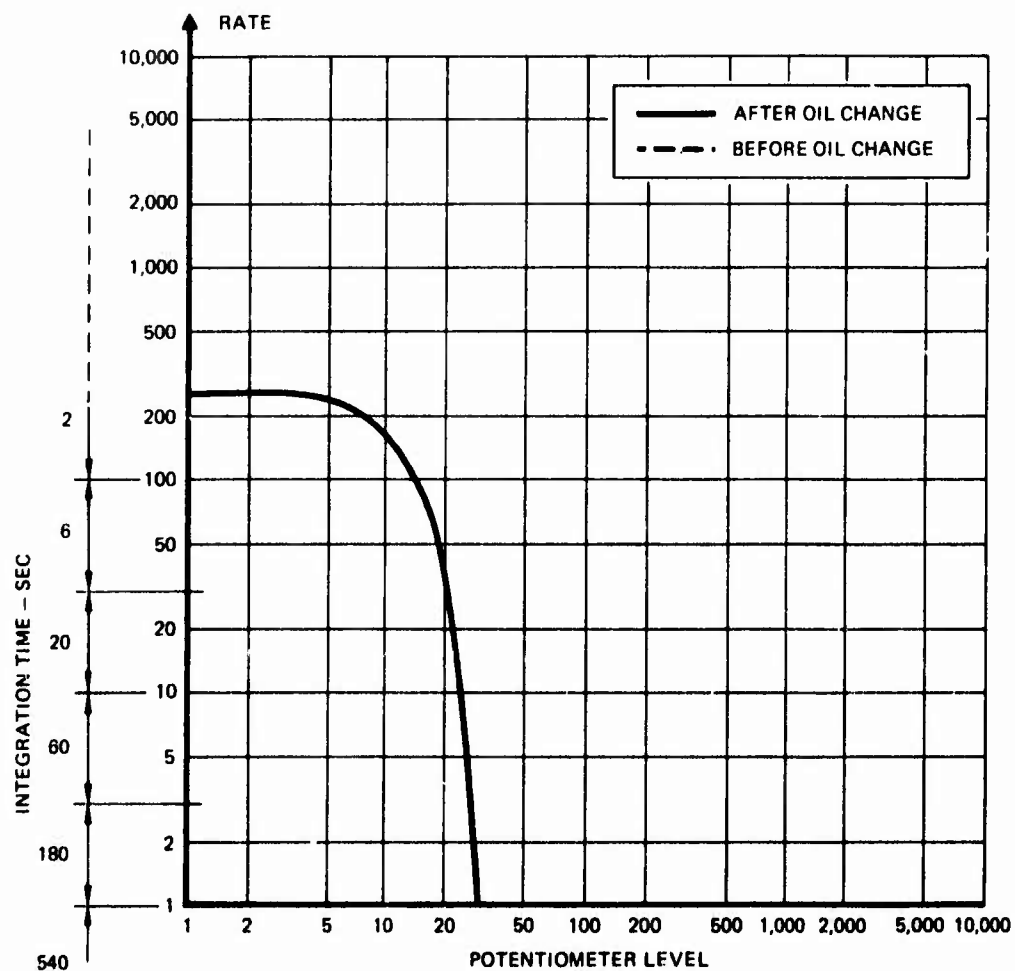
Figure 65. Shock Emission Profile - BBT Startup, First Test Period

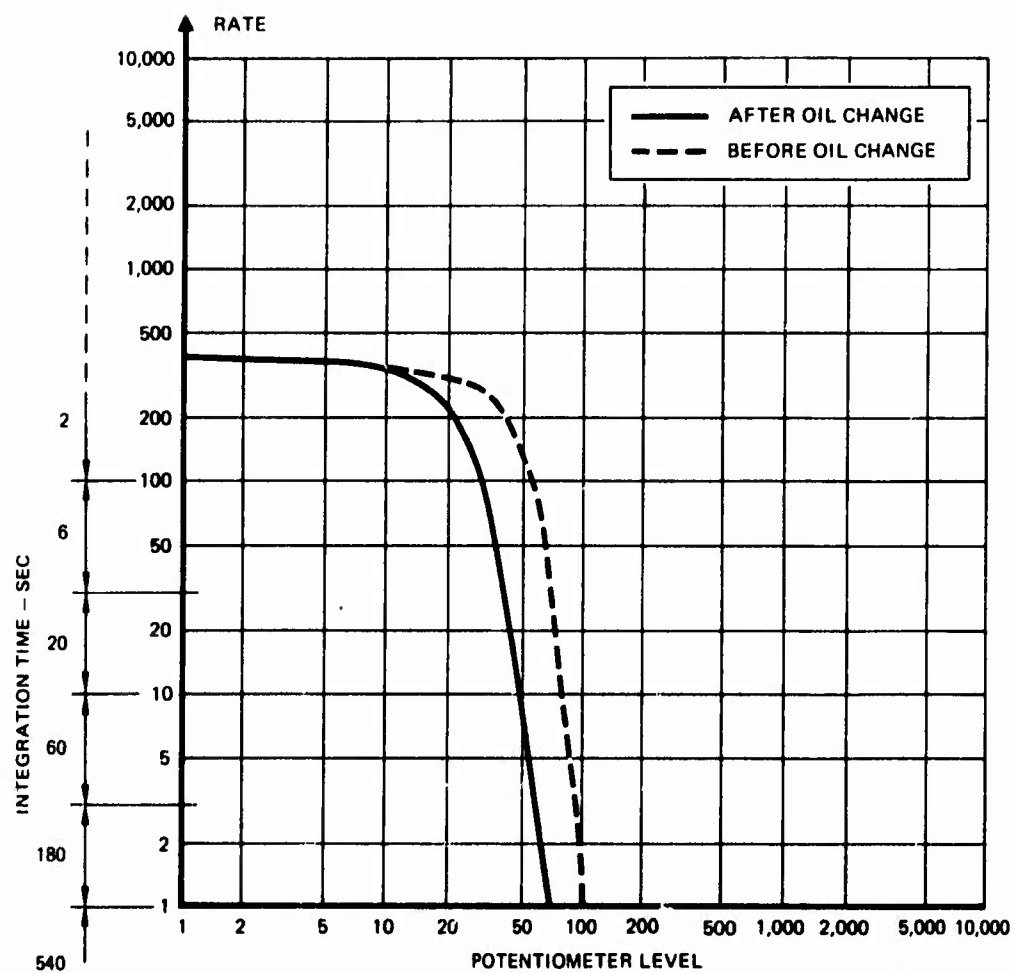
Figure 69 shows the shock emission profile taken at the peak of the second period of excessive wear at slightly later than 300 hours. Note the reduction in the peak values after the oil change.

Figure 69. Shock Emission Profile - BBT, Peak of Wear Period.

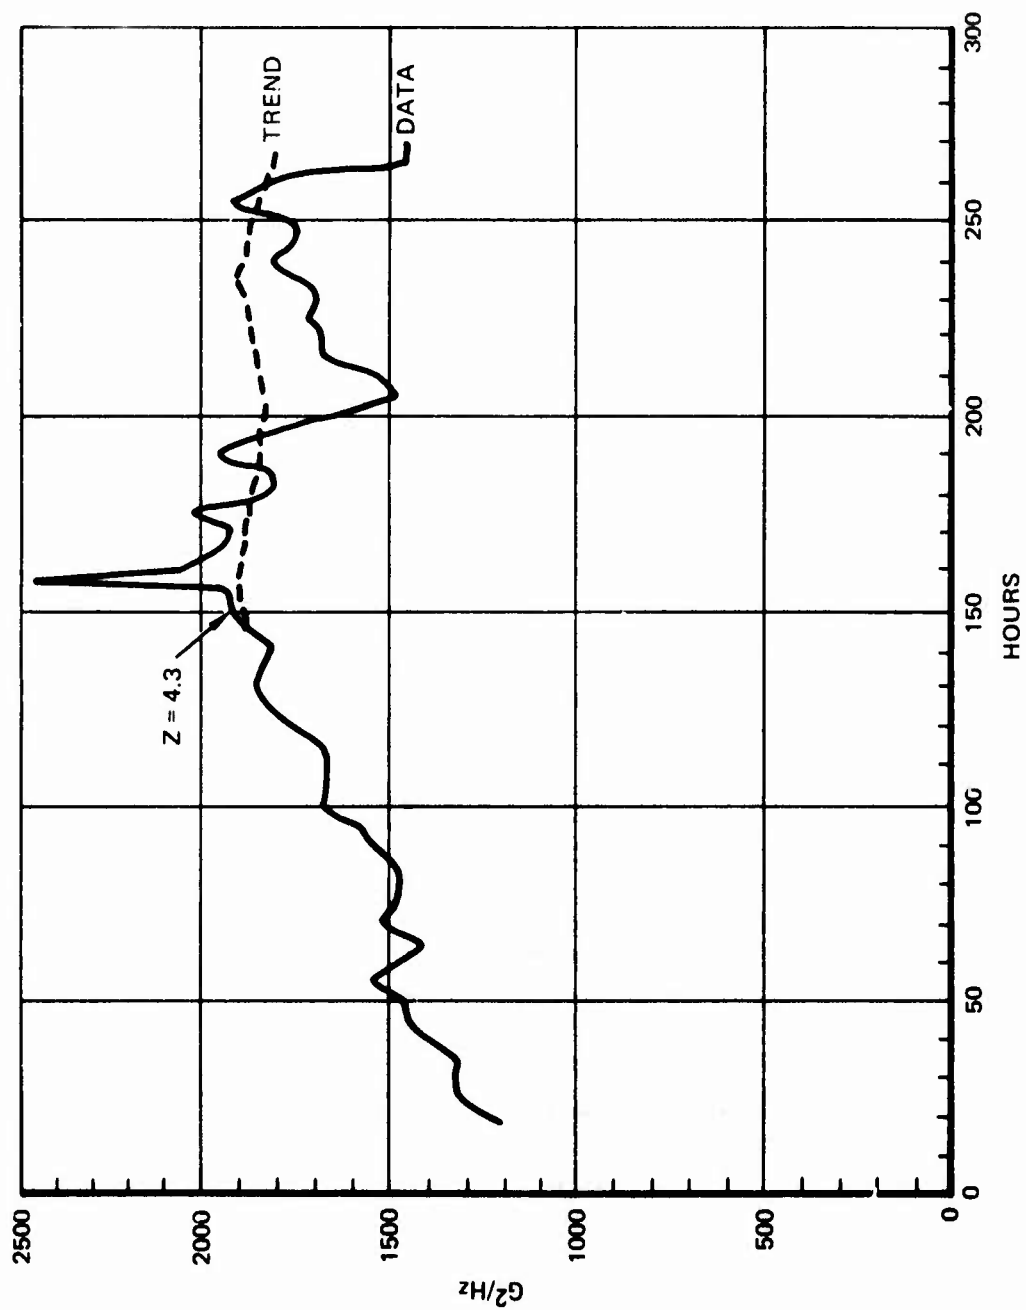
Figure 78. Prognostic Trend of BBT Gearbox, Input Lateral Accelerometer, 1172 Hz.

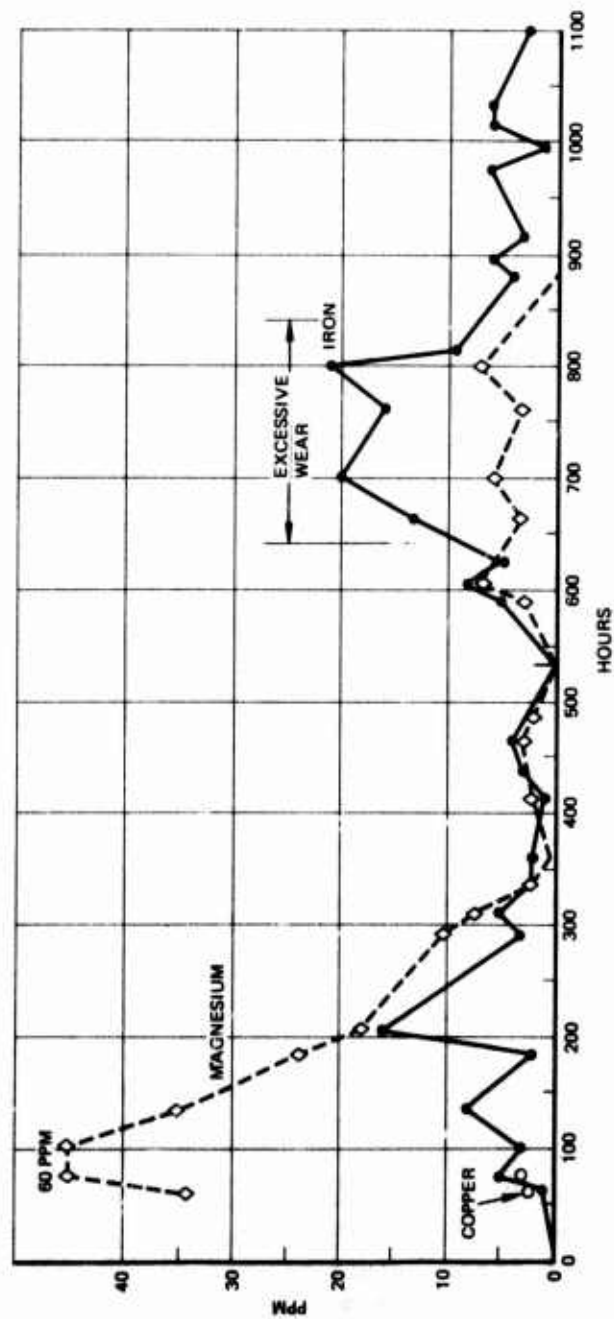
Shock emission profiles were collected before and after each oil sample that was taken for the SOA. Representative examples of this data are shown in Figures 80, 81, 82 and 83. Figure 80 shows the shock pulse data after the first 62 hours of running. The large change between dirty and clean oil is due mainly to the "green run" condition, i.e., the newly assembled gearbox is undergoing accelerated wear due to microscopic misalignments. As shown in the previous section on spectroscopic oil analysis, the iron content at this time is 8 ppm, but the magnesium concentration is extremely high. The shock emission profiles remained relatively unchanged until test hour 725, when the iron content jumped to 27 ppm, apparently indicating the onset of a heavy wear period. At the 800-hour point, the shock emission profile, Figure 81, does not show the earlier observed effects of used oil, despite the fact that the used oil was a dark grayish brown after only 17 hours of running between oil changes. The iron concentration at this time was 21 ppm. For the next 165

Figure 79. Spectroscopic Oil Analysis Summary, BB3.

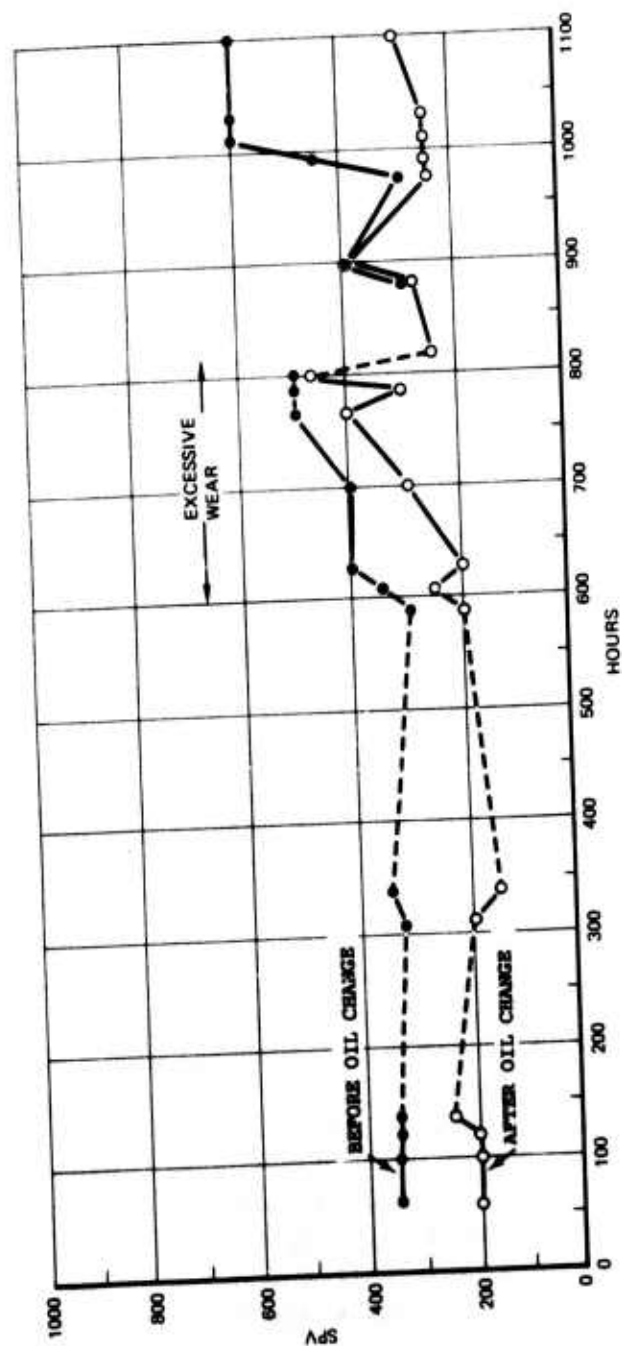
Figure 84. Shock Pulse Value Data, BB3.

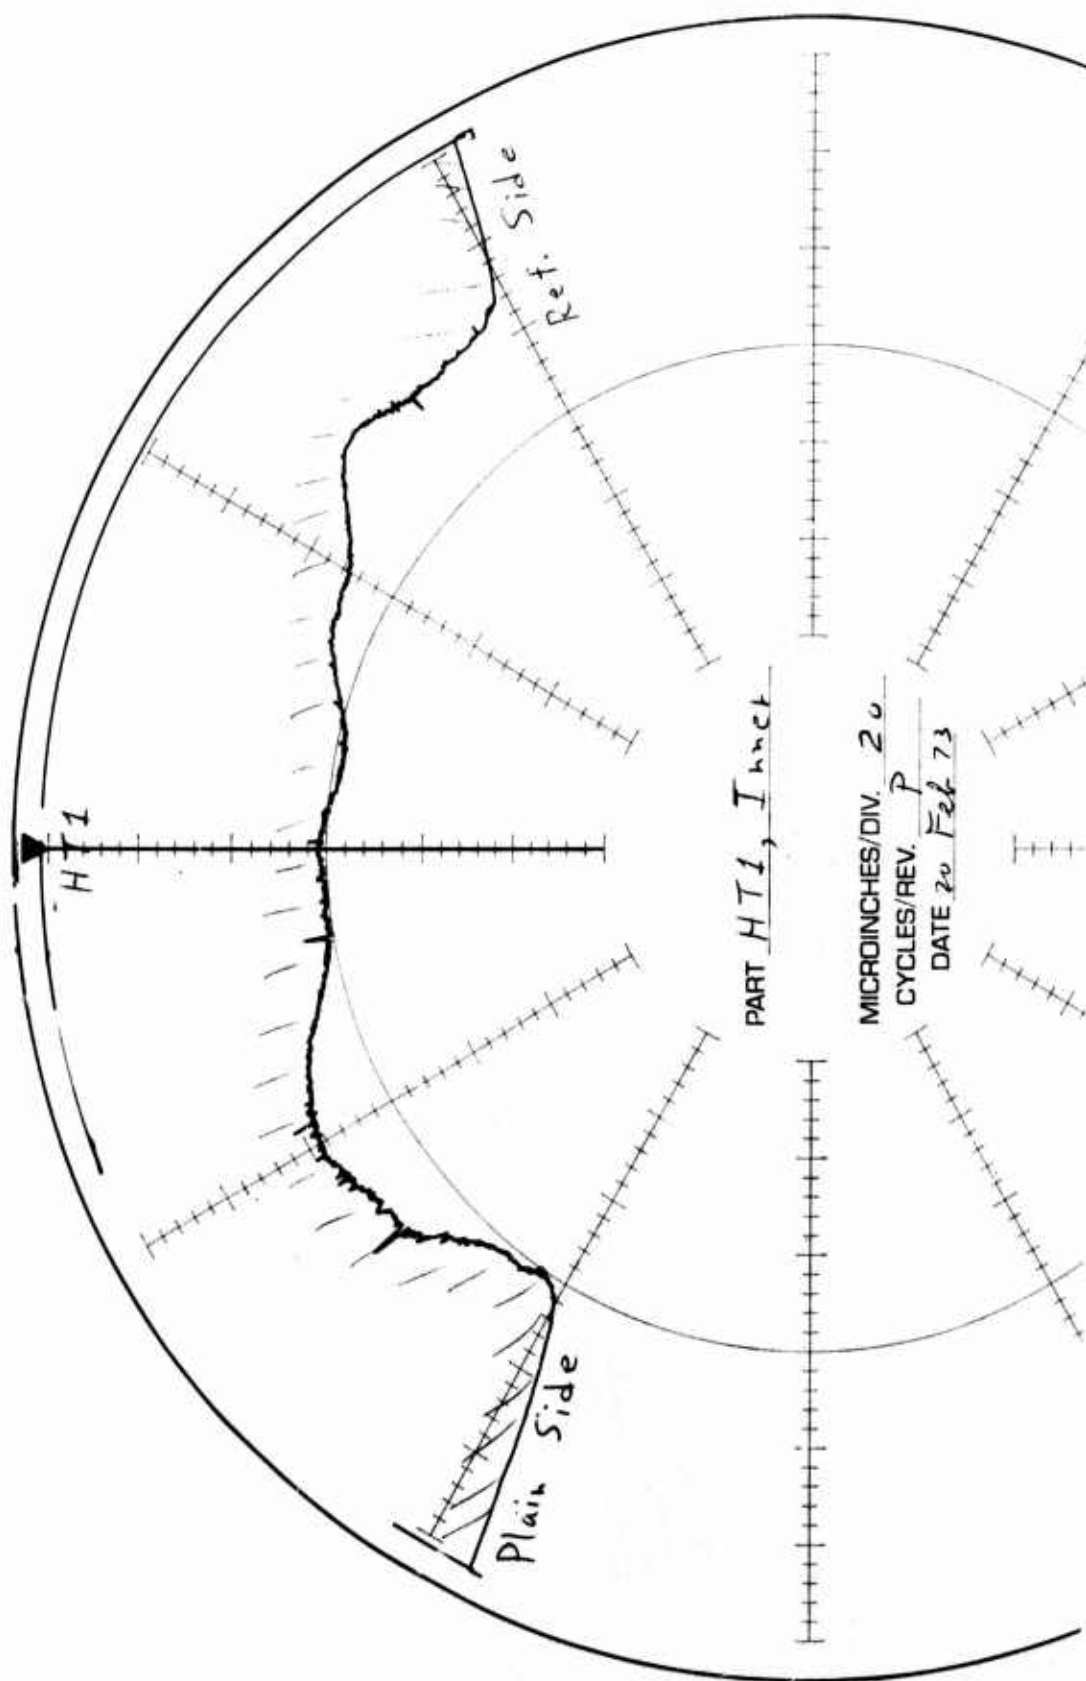
Figure 92. HT-1 Cross-Groove Profile at Zero Test Hours.

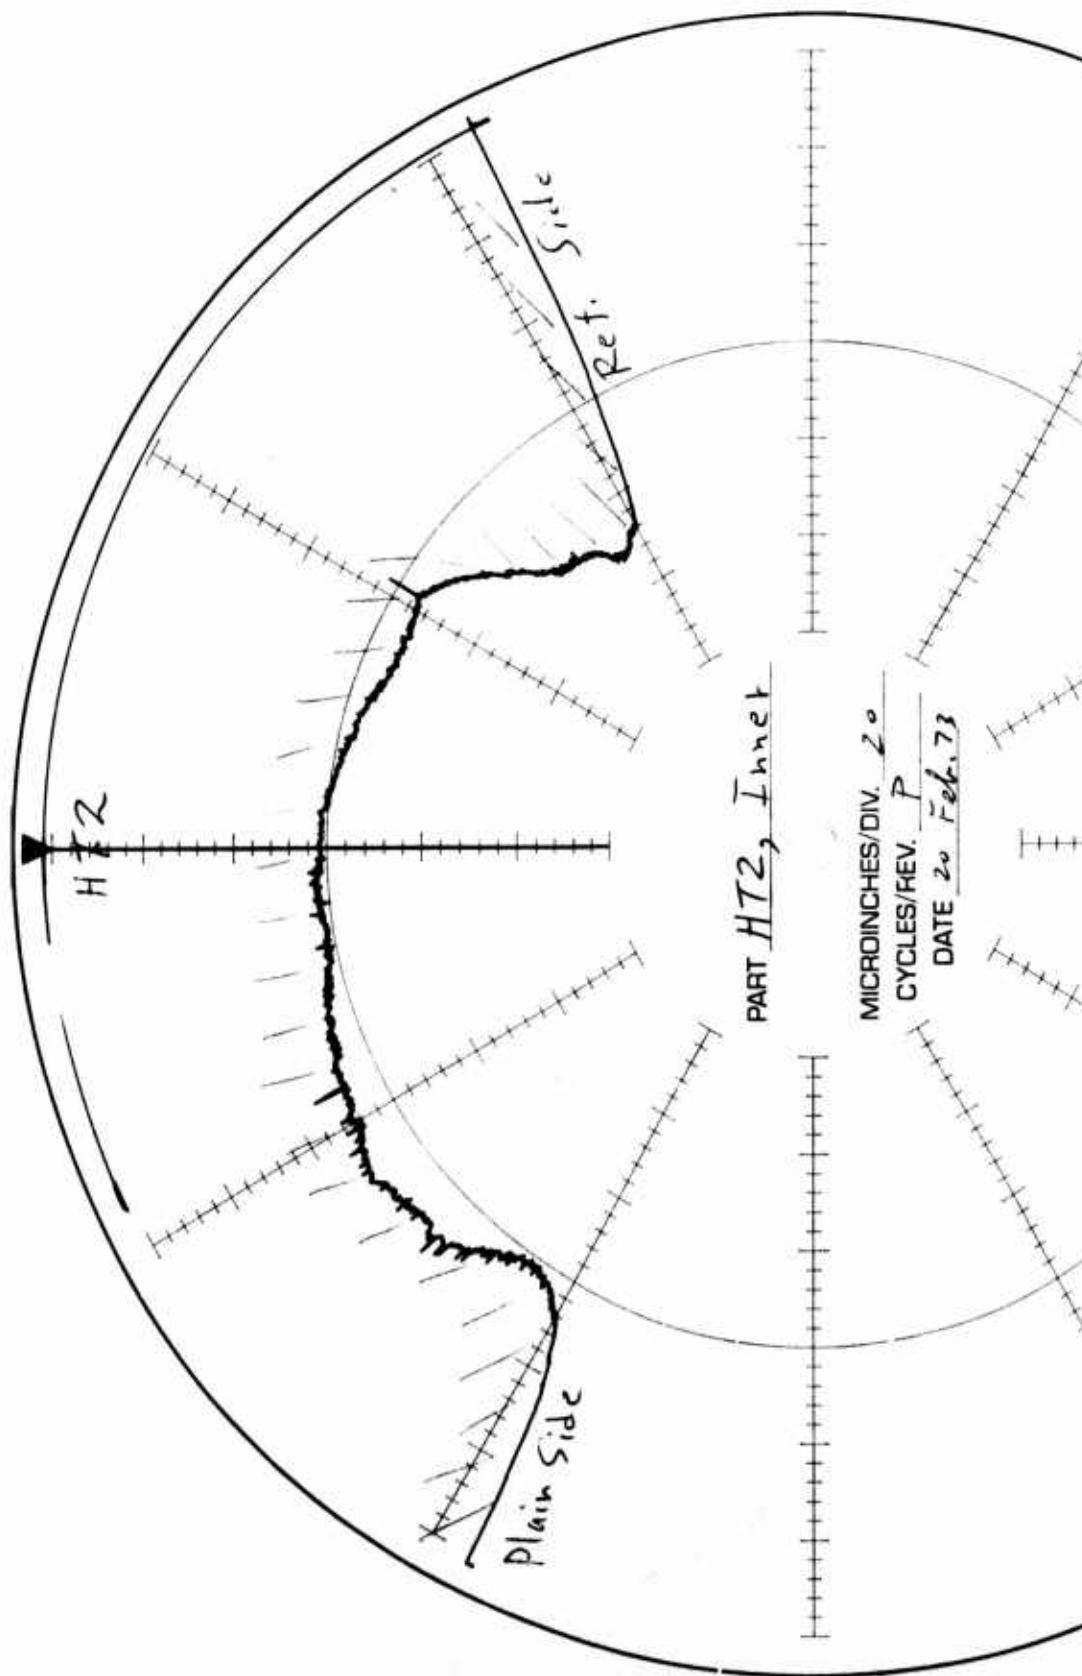
Figure 95. HT-2 Cross-Groove Profile at Zero Test Hours.

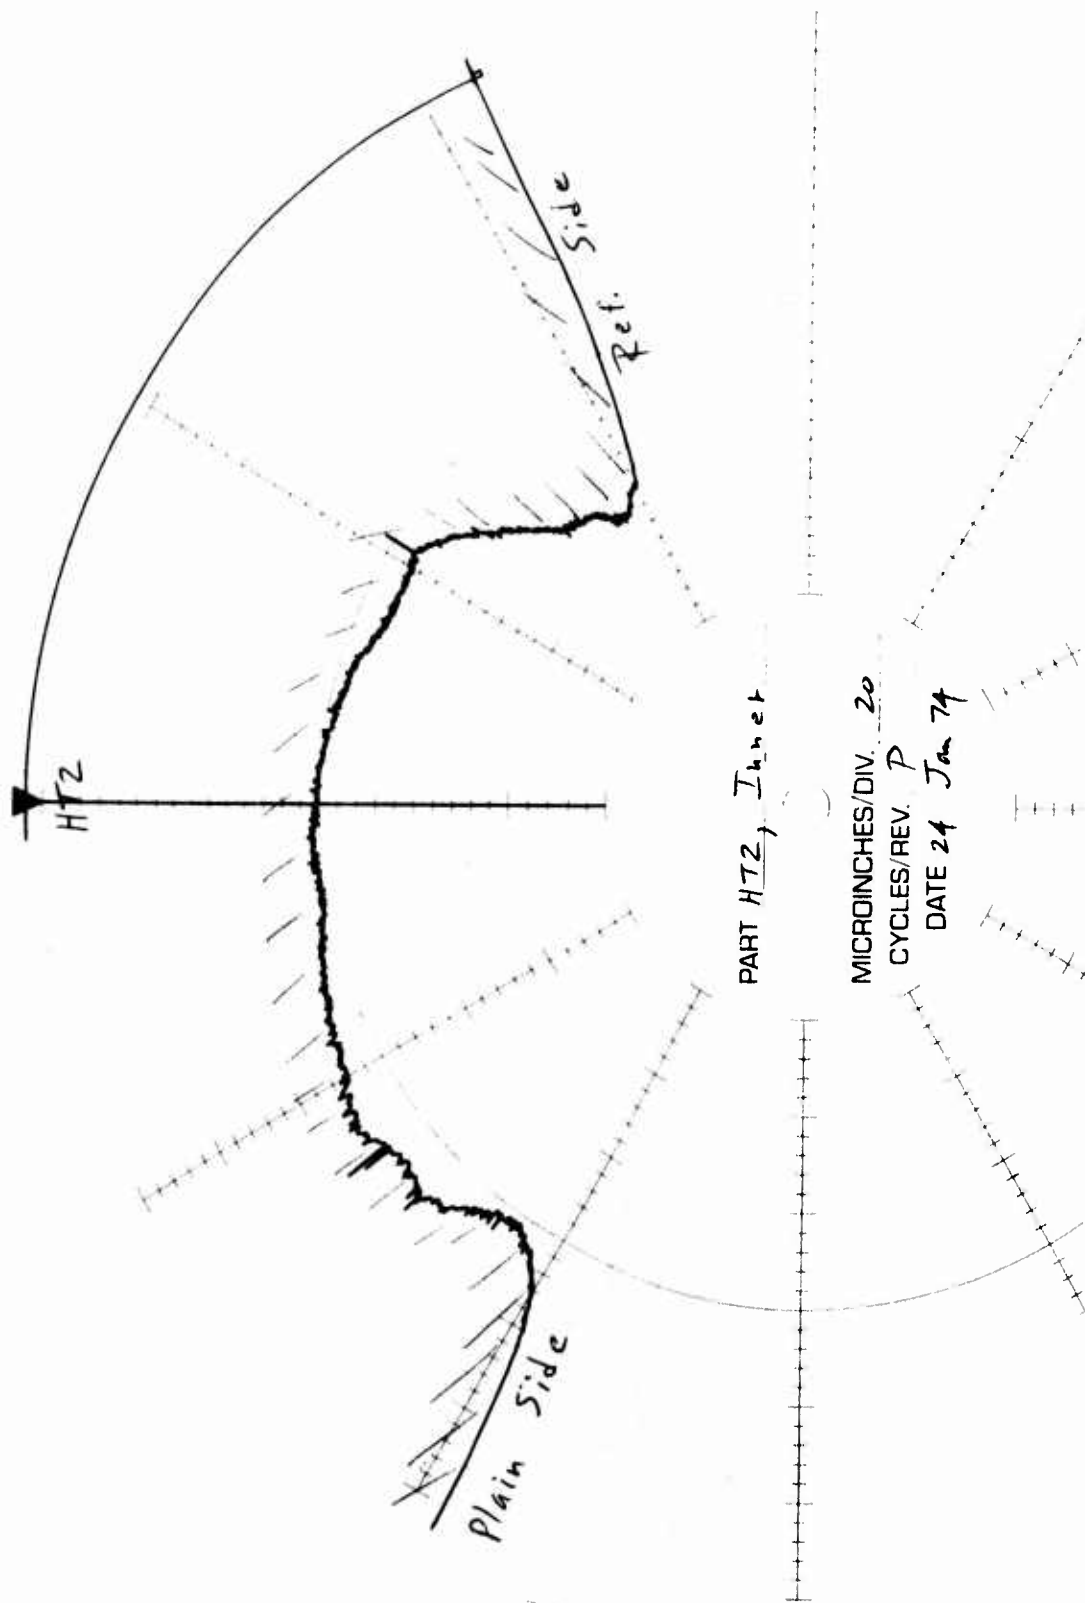
Figure 96. HT-2 Cross-Groove Profile at 877 Test Hours.

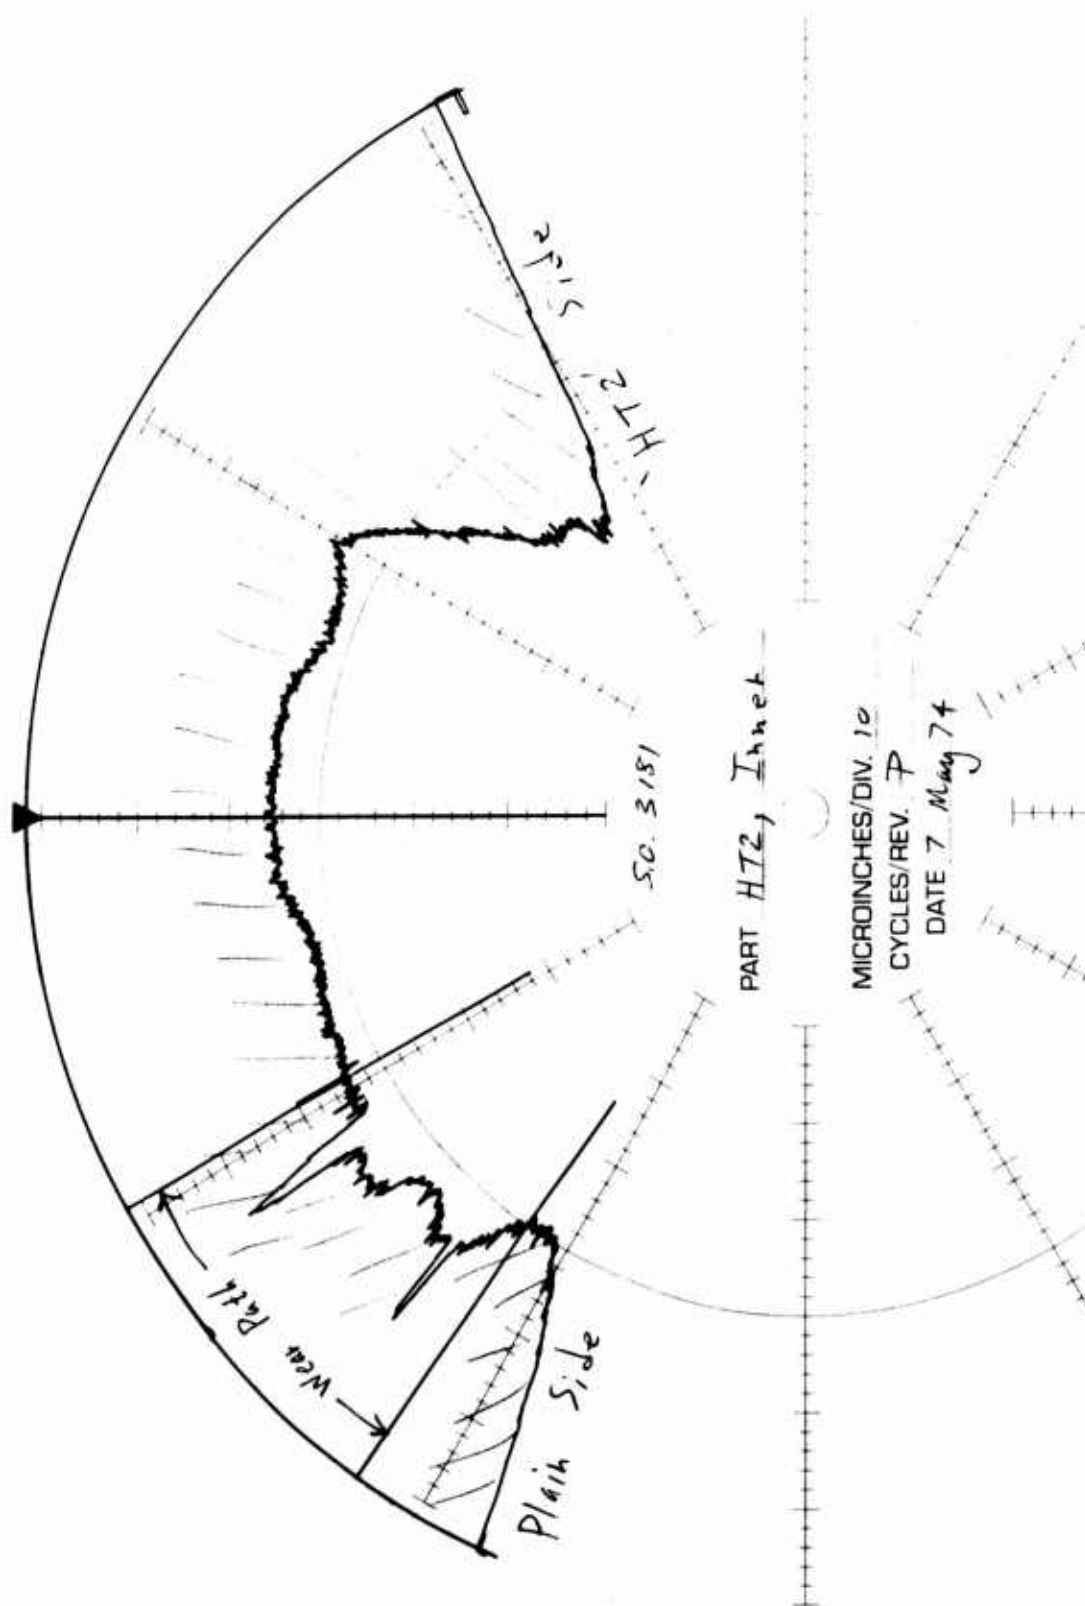
Figure 97. HT-2 Cross-Groove Profile at 1454 Test Hours.

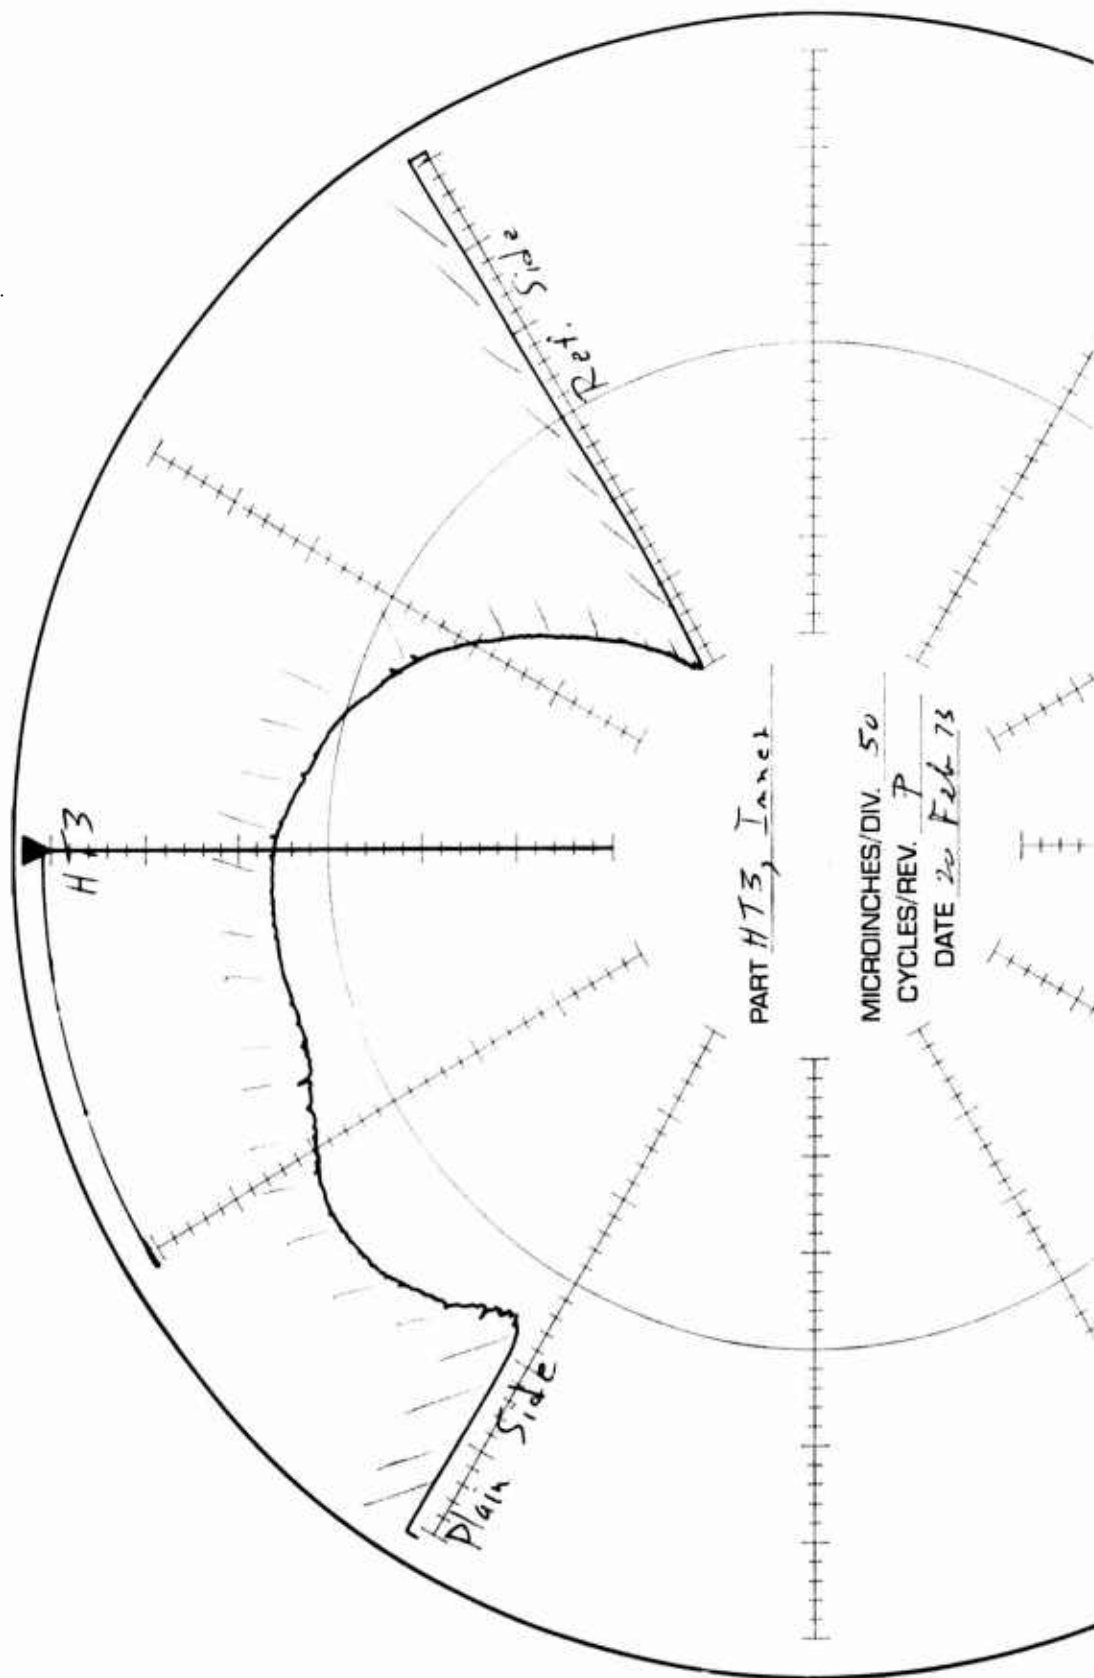
Figure 98. HT-3 Cross-Groove Profile at Zero Test Hours.
